C-5149-14-H

Property Condition Report-Terracon Project Number 92088503
Memorial Middle School, Pharr-San Juan-Alamo ISD, Pharr, Texas
Photos, Date Taken: January 7, 2008

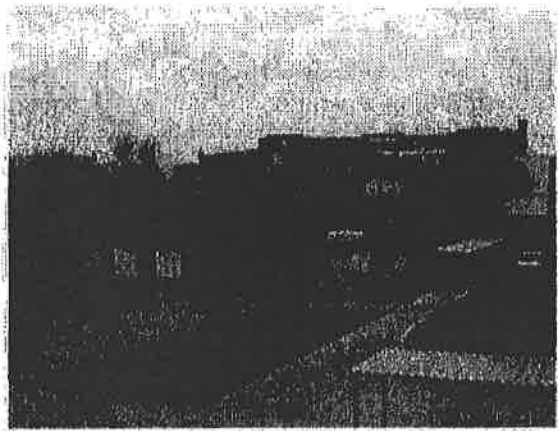
Photo #4 View of auditorium wing of Main Building and Classroom Annex II.

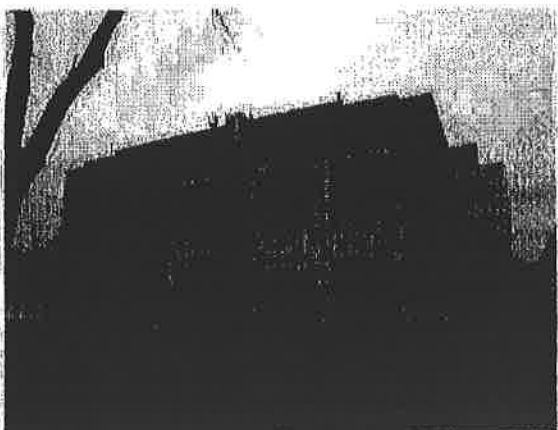
Photo #5 West elevation of Main Building.

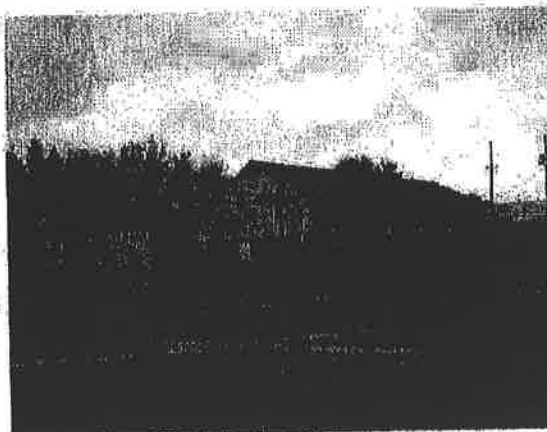
Photo #11 North and west elevations of Cafeteria Building

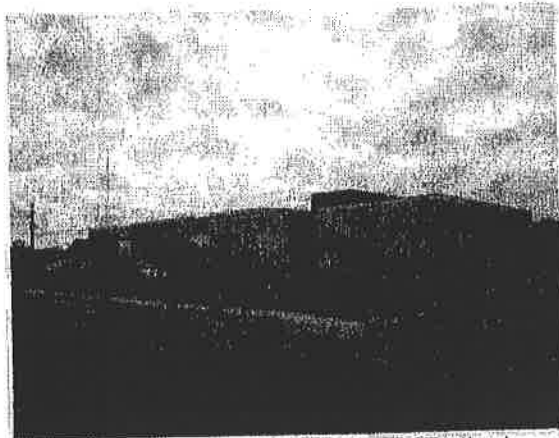
Photo #19 East and north elevations of Textbook Department Building.

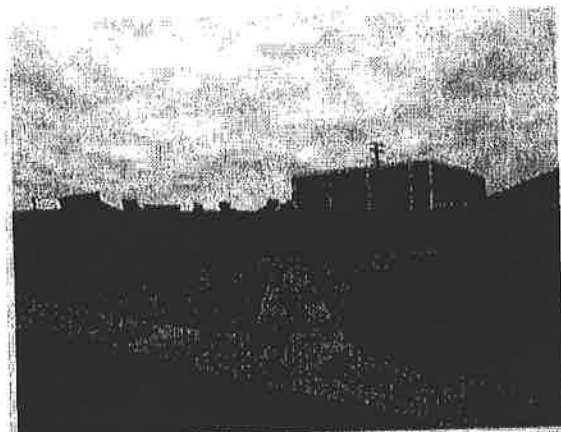
Photo #22 East and north elevations of Gymnasium and Field Locker Room building.

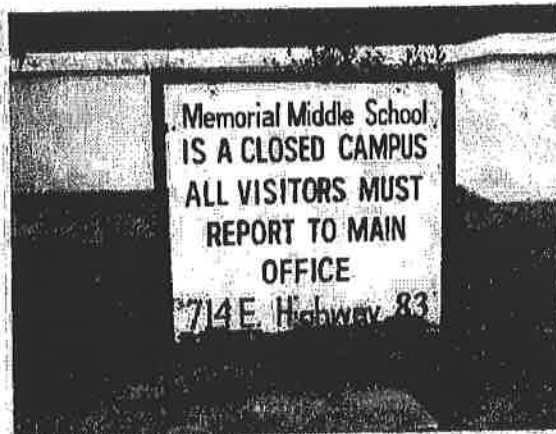
Photo #31 Main Building signage.

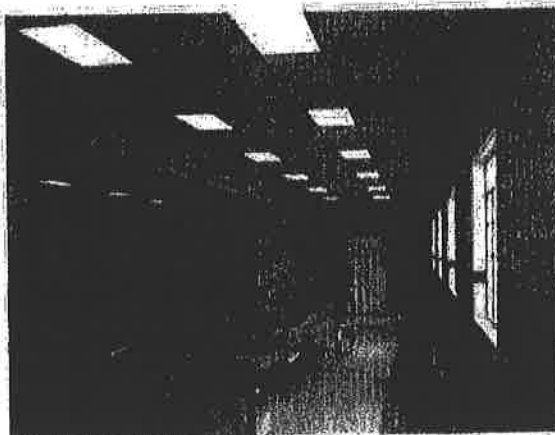
Photo #65 Cafeteria

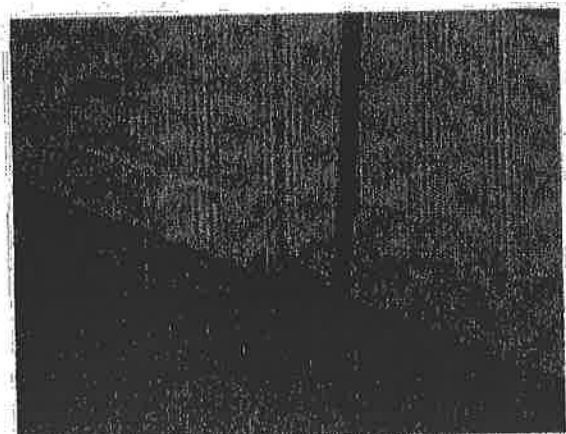
Photo #90 Cafeteria serving area walls.

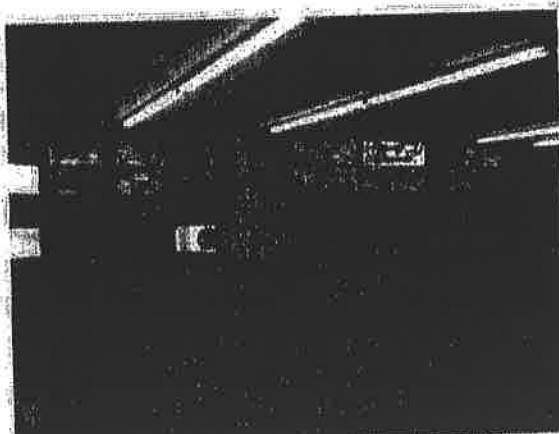
Photo #107 Existing classrooms of Main Building.

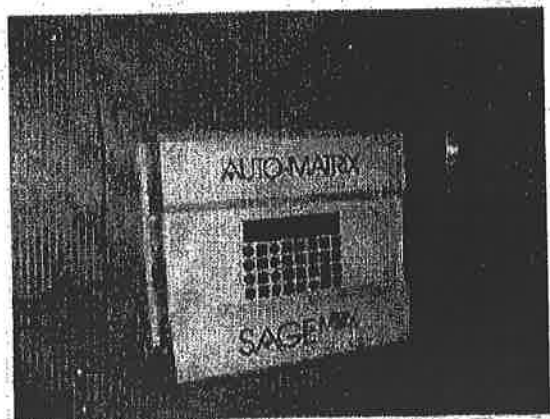
Photo #120 Automatrix building automation system installed in the Main Building

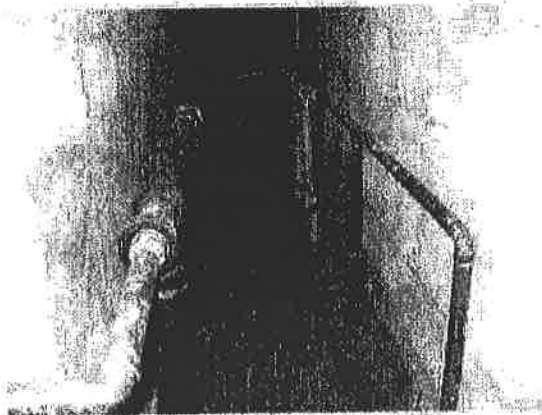
Photo #129 Copper, PVC, and cast iron piping in the Textbook Department Building
